LANDCARE FOR THE FUTURE

SANTIAGO DE COMPOSTELA, JULY 16-18, 2018

FIELD TRIP 1

RESTORATION OF THE TOURO MINE: WATER CONSERVATION AND CARBON SEQUESTRATION

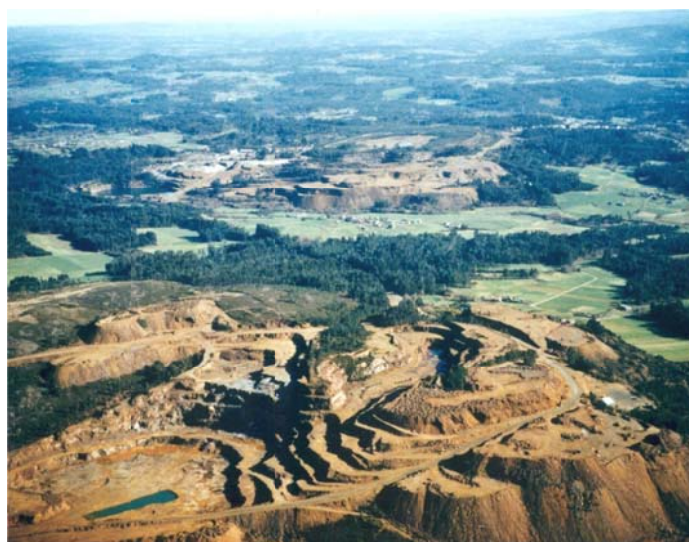
The Touro mine is located in a formation of amphibolites mineralized with metal sulphides, mainly pyrite and pyrrhotite. This open cast mine was originally exploited for copper (1974-1988) and more recently for building aggregate. After the mine was closed, the pit faces, spoil dumps, trituration and flotation installations, and the sludge pond were abandoned to the elements for several years. As part of the restoration work, which began in the late 1990s, some of the faces have been partially or totally covered with water and the sludge pond has been partially filled in with soils from the area, and revegetated.

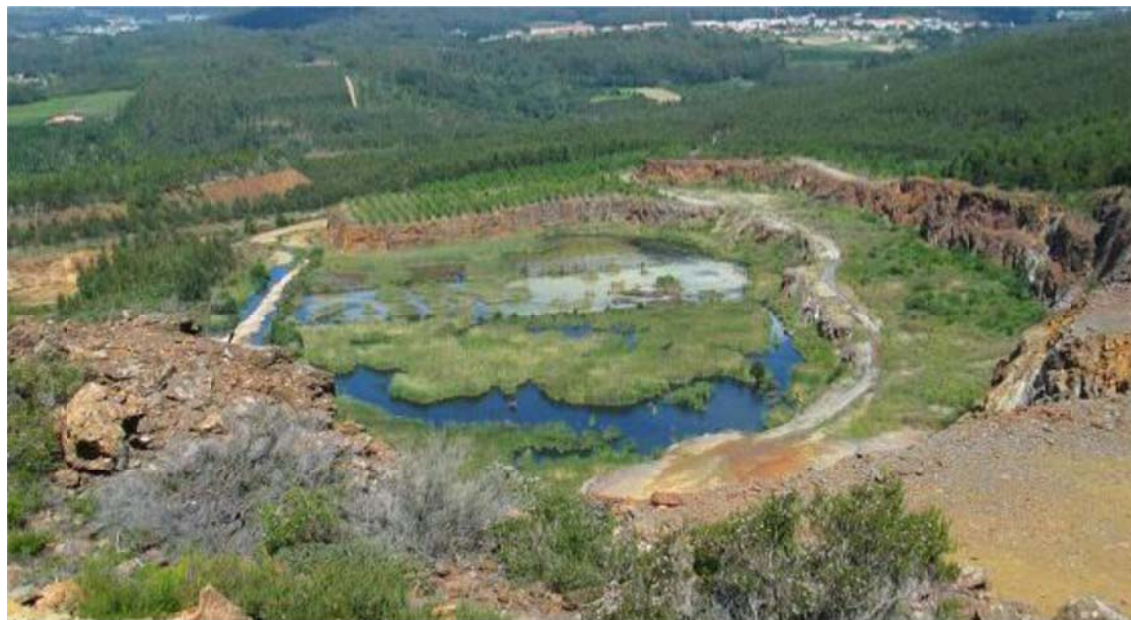
Development of one of the zones where correction of acidic waters has been achieved by the use of Technosols and creation of a wetland environment.

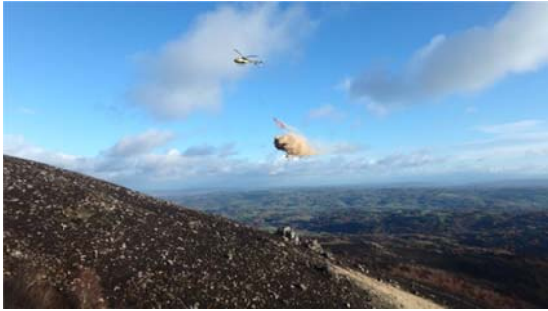
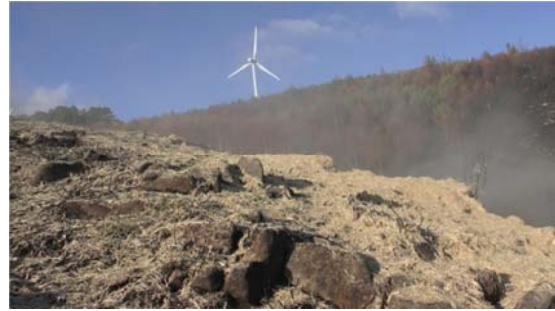
Performance of heli-mulching in Monte Faro

To ensure the recovery of ecosystems, a protocol of urgent soil protection techniques against erosion was implemented at Mount Faro. These techniques focused mainly on the areas of greater severity, especially those of more slope and close to the water courses. The most important protection technique was mulching with cereal straw. The application was made by helicopter.

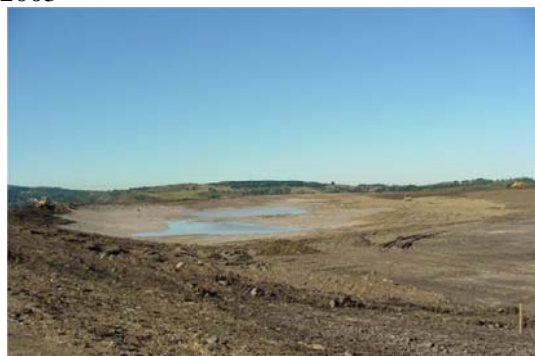
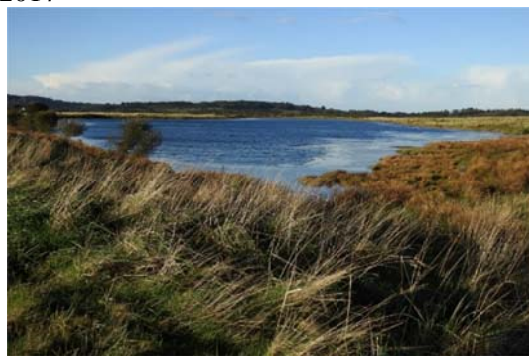
Evolution of the Seixo pond from its preparation to the present

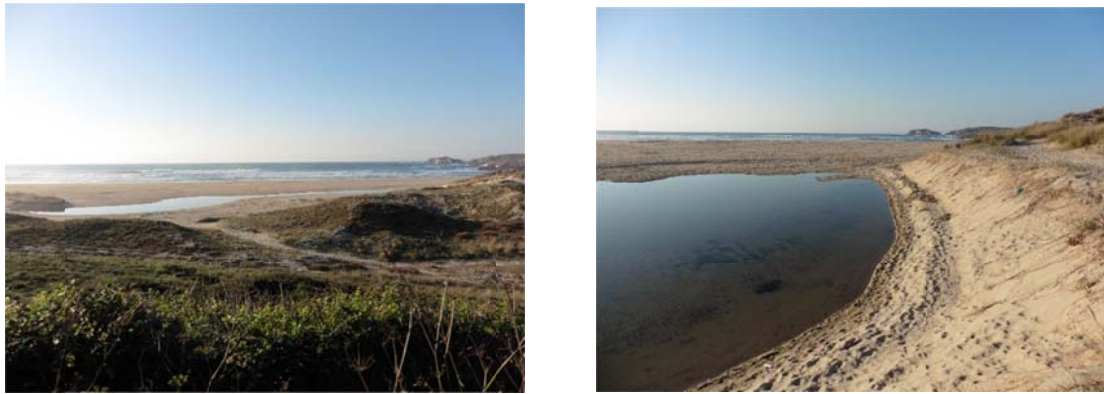
Figure 2. Images of the dune system in Doniños (1/12/2015)

Among the dune habitats that will be visited during the field trip, it is remarkable the presence of the particularly fragile 2130* priority habitat “Fixed coastal dunes with herbaceous vegetation (grey dunes)”, and 2150* priority habitat “Atlantic decalcified fixed dunes (*Calluno-Ulicetea*)”. The Doniños dune system also exhibits a good representation of 2120 “shifting dunes along the shoreline with *Ammophila arenaria* (white dunes)” and of 2110 “Embryonic shifting dunes”, 2230 “*Malcolmietalia* dune grasslands” and 2260 “*Cisto-Lavenduletalia* dune sclerophyllous scrubs”. In addition, where the underlying water table reaches the surface, the system is diversified by the presence of 2190 “humid dune slacks”, the wetland component of dune systems.
